SAFETY INITIATIVES IN THE RURAL EASTERN CAPE

NATIONAL ROUTE R61 SECTION 8

PETER HENDERSON Pr Eng

The paper describes the implementation of safety improvement measures on the R61 Section 8 between Mthatha and Port St Johns.

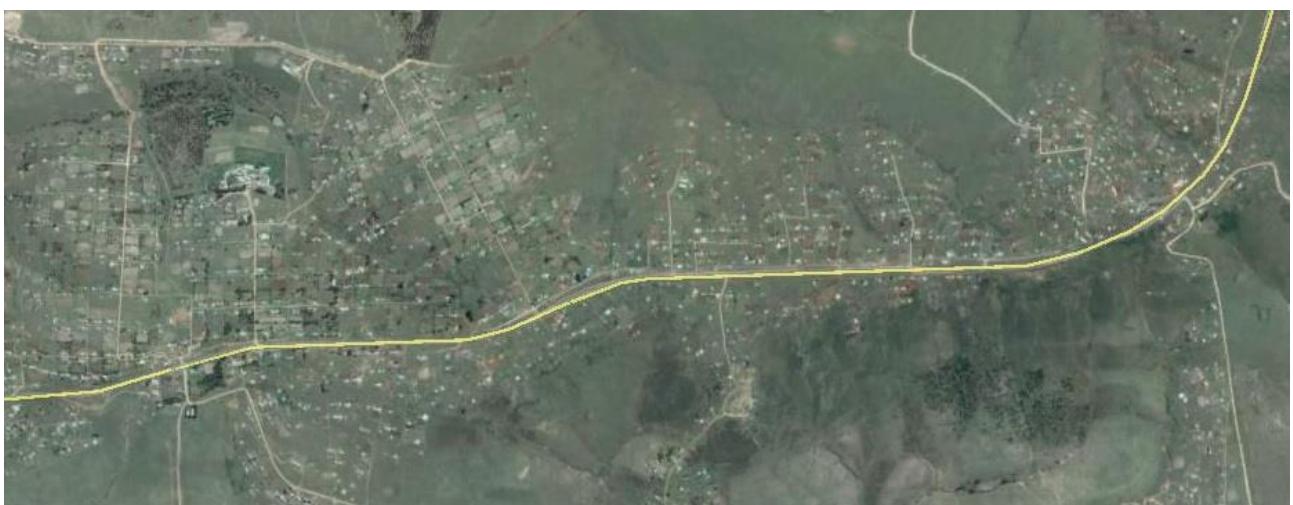
This area is also typified by ribbon developments along the major roads. With the poor riding quality and infrequent maintenance of the roads, communities favour access onto the surfaced roads. Figure 2 shows a portion of the route illustrating the typical ribbon development that occurs along the route.

Figure 2 : Typical ribbon development (image from google earth)

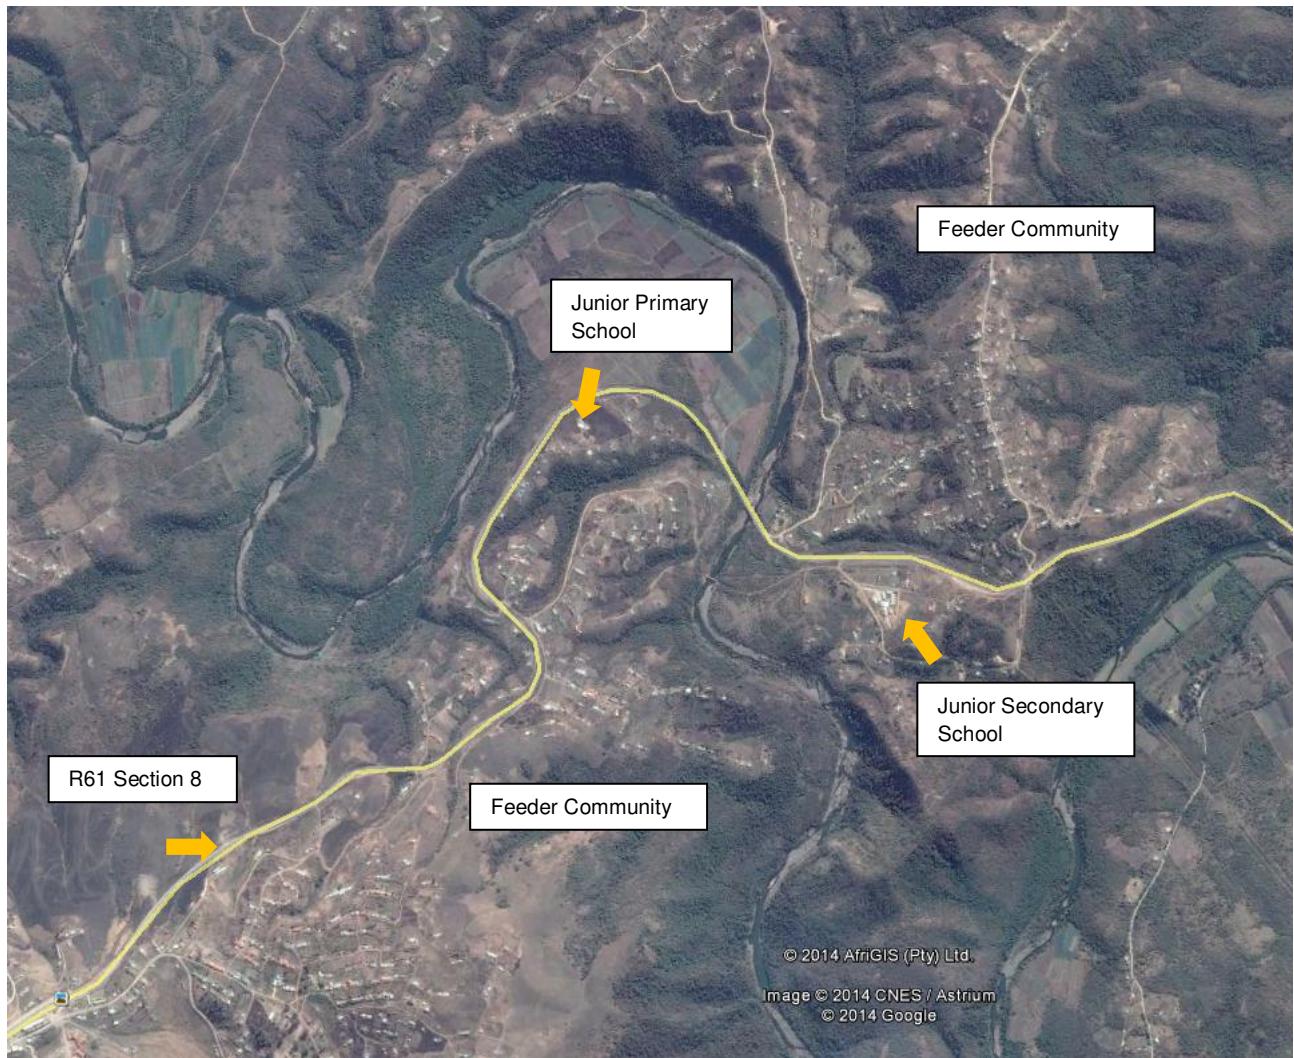
The location of government services has not been co-ordinated and as such has resulted in road safety aspects being ignored in the development of infrastructure. Examples of this are the construction of schools across the road from the school feeder population. This is illustrated in Figure 3 below.

Figure 3 shows that the lack of planning has resulted in easy access for the teachers, but the positioning of the schools requires pupils to either walk on the R61 or to cross it. No provision was made for the safe movement of learners to the school.

Figure 3 : Community infrastructure (image from google earth)

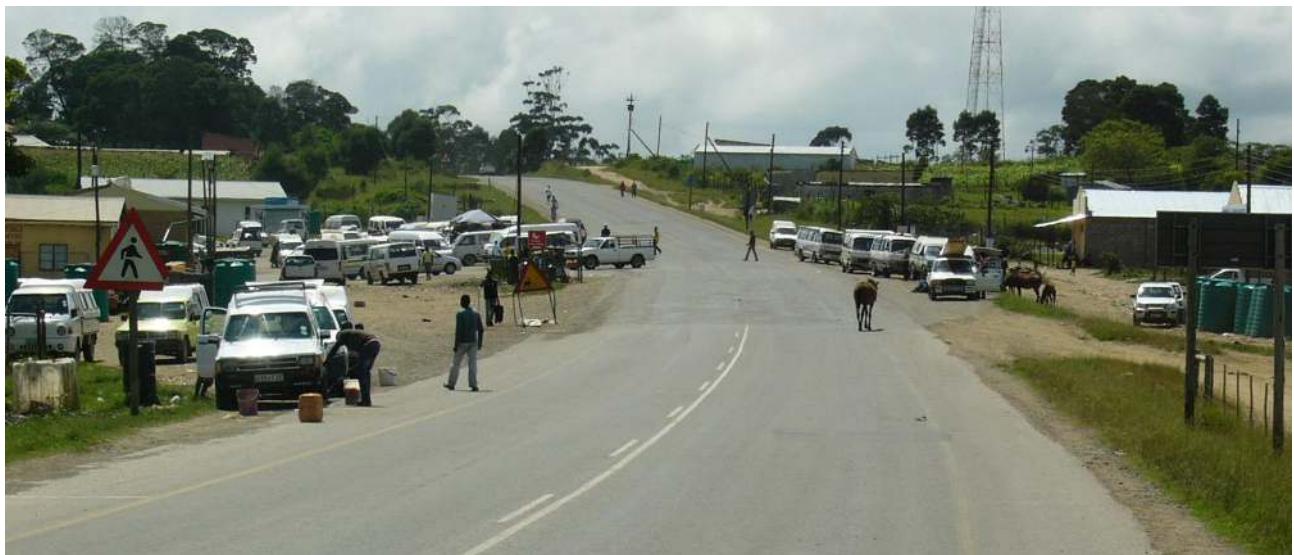
Vehicular safety concerns related to right hand turning movements as well as uncontrolled and informal accesses onto the R61. Image 1 shows a typical uncontrolled access and vehicle parking onto the R61.

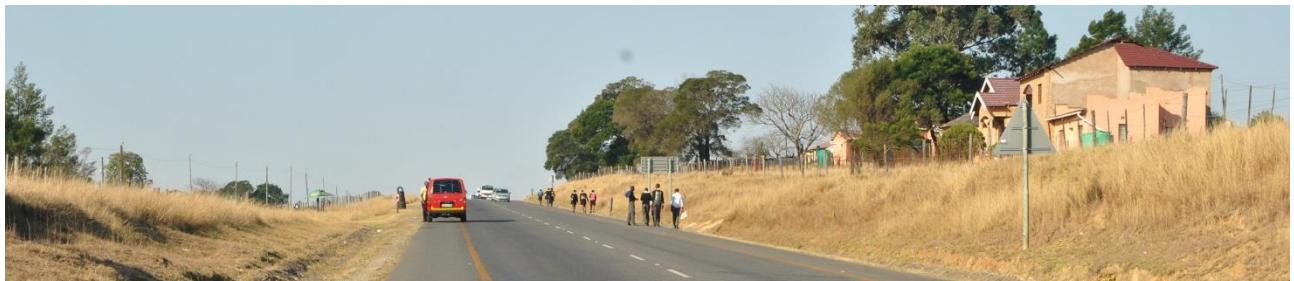
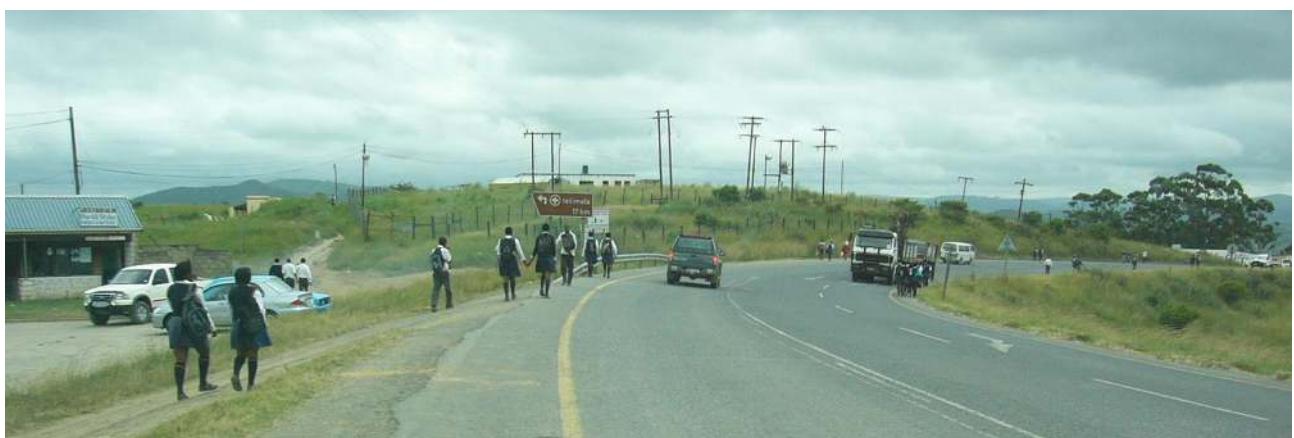
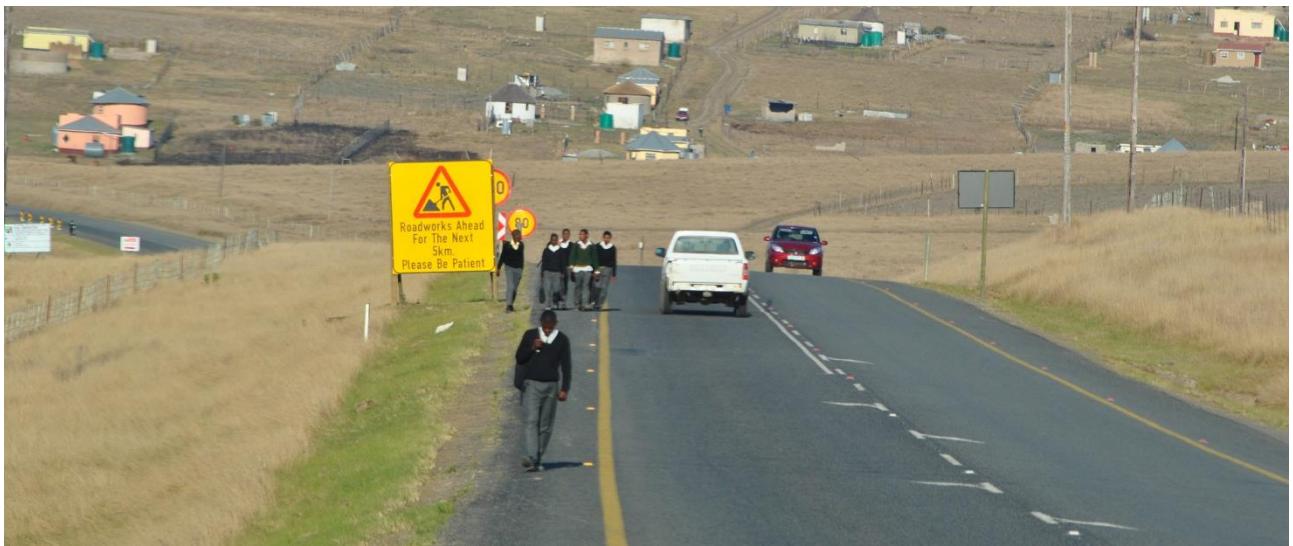
Pedestrian safety concerns included pedestrians crossing the R61 as well as pedestrian usage of the R61 by walking on the bitumous surface inside of the yellow line. Images 2, 3 and 4 illustrate this occurrence.

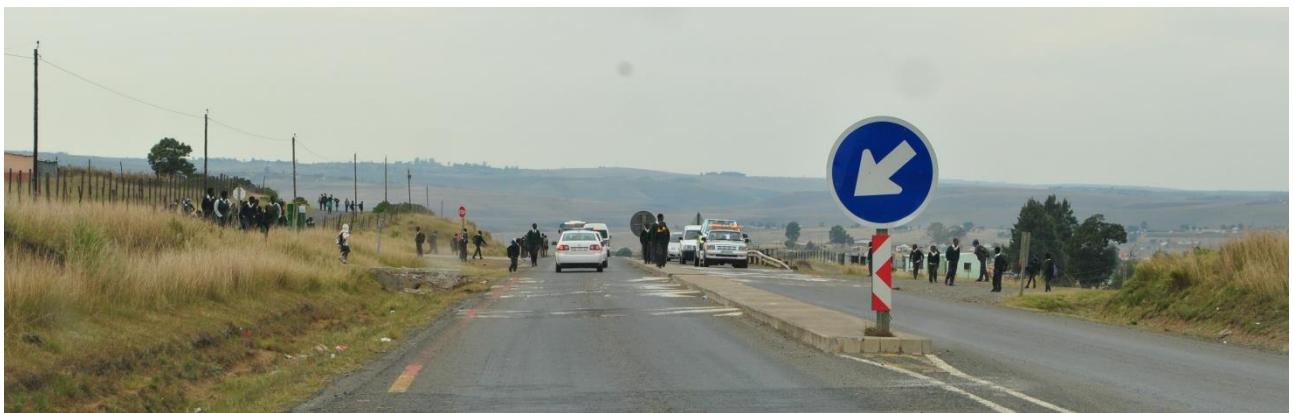
Image 5

At four areas along the route, pedestrian crossing movements have been accommodated by the placing of speed humps with a raised central median (image 5).

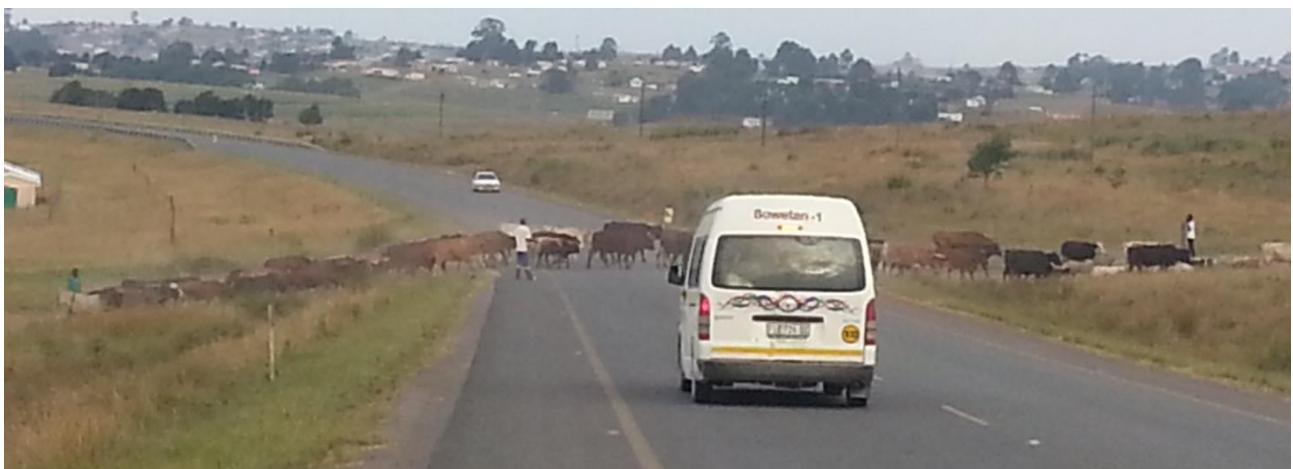
Livestock are herded across the R61 at various points. The crossing areas are not sign posted so motorists have no advance warning of the potential conflict area. Image 6 is an example.

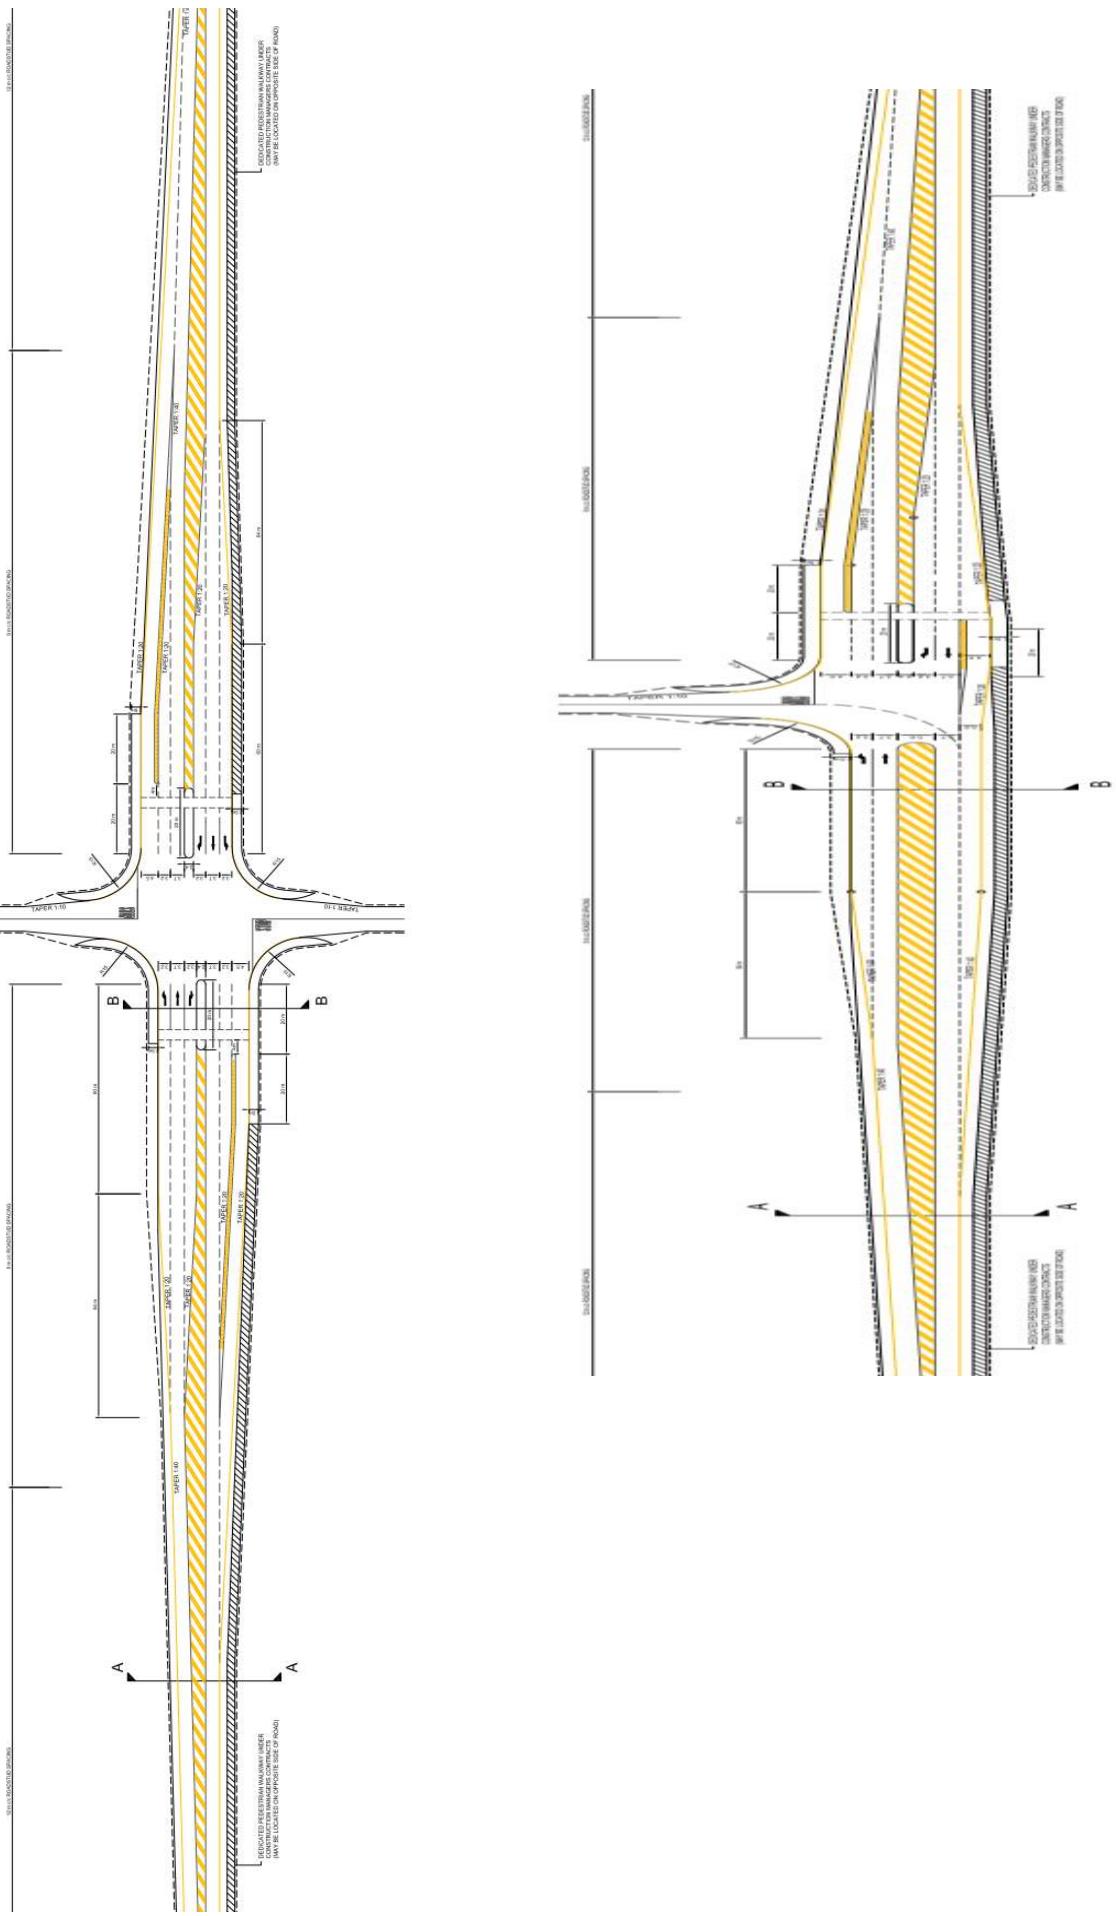
The next feasible option was to change the visual appearance of the road so that the motorist would be more observant because the road way had changed significantly. In order to achieve the visual change from a motorist's perspective, each intersection was widened with a central dedicated turning lane. Prior to the development of this lane the through lane was diverted to the left to create the area required for the turning lane. Taper rates were designed for a 100km/h vehicular speed.

The turning lane was protected from being used as a through lane by the placing of rumble strips and road studs. Figure 4 provides a layout of the proposed intersection.

Figure 4 : Typical intersection design

In order to achieve this, dedicated pedestrian crossings were allowed for at each intersection. The crossings were located at the taxi drop off points. The addition of an extra lane increased the road width to a point that it was felt would be too wide for a pedestrian to cross in one movement. As such a central refuge needed to be created so that pedestrians only needed to cross traffic from one direction.

The provision of a central painted median provided sufficient refuge. The rumble strips and road studs would provide sufficient warning to motorists should they deviate off the through lane and onto the painted median. It was further felt that pedestrians would require a raised median to indicate where the refuge was, thus providing a measure of intangible reassurance that they were standing in the correct place. To this end, a raised median was designed and placed on the painted median at the allocated pedestrian crossing.

In order to prohibit the raised median from becoming a potential accident risk to vehicles, should they continue on the painted median, the median would be constructed from mountable kerbs and would protrude a maximum of 60mm above the road level.

Pedestrian walkways are included in the intersection to provide dedicated pedestrian routes outside of the roadway. The walkways are further separated from the roadway by guardrails. The guardrails are maintained until the walkways are separated from the roadway and are located at the outside of the road reserve.
