Maintenance engineering standards  
to fulfil the legal duty of  
road authorities towards safe roads

Louis de Villiers Roodt

*Dissertation presented for the  
Degree of Doctor of Philosophy  
Faculty of Engineering  
Stellenbosch University*

March 2016

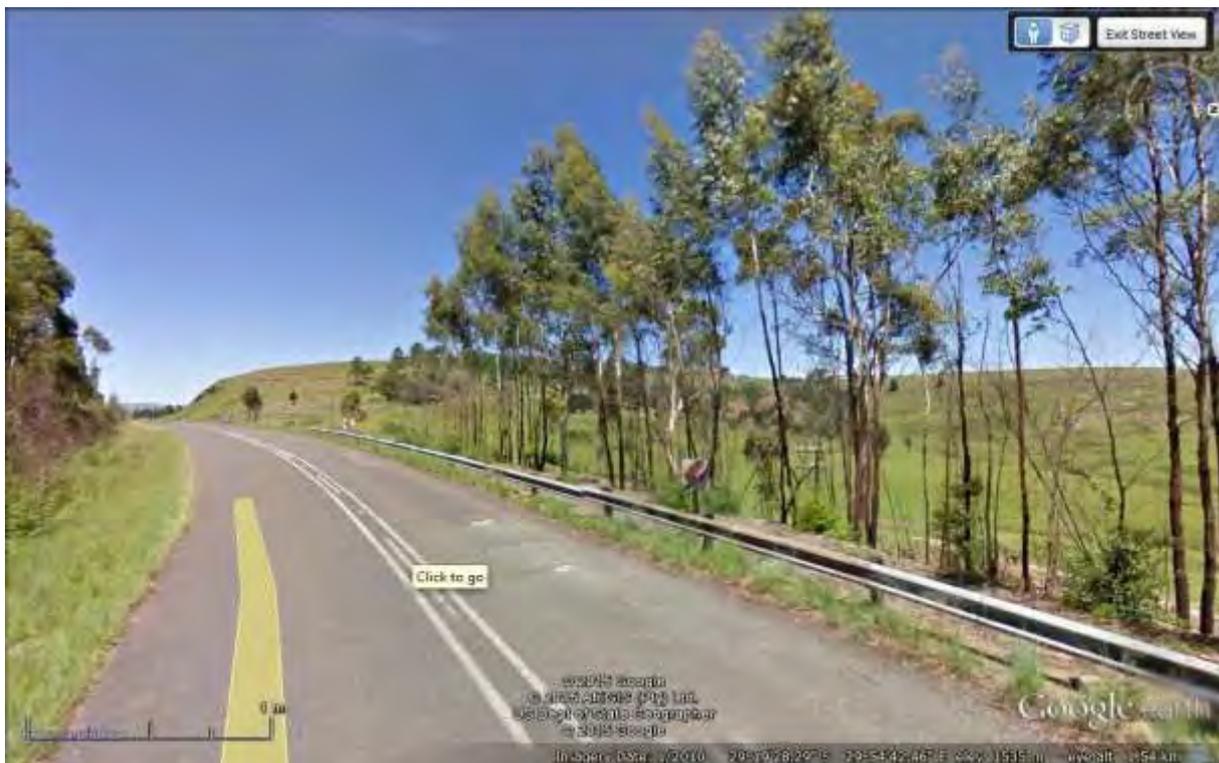
The road was repaired in 2004 after the accident. In 2010 the road again showed potholes in the curve where the accident happened.

**Figure 7- 6: McIntosh: 2010 Google Streetview of curve where accident happened**

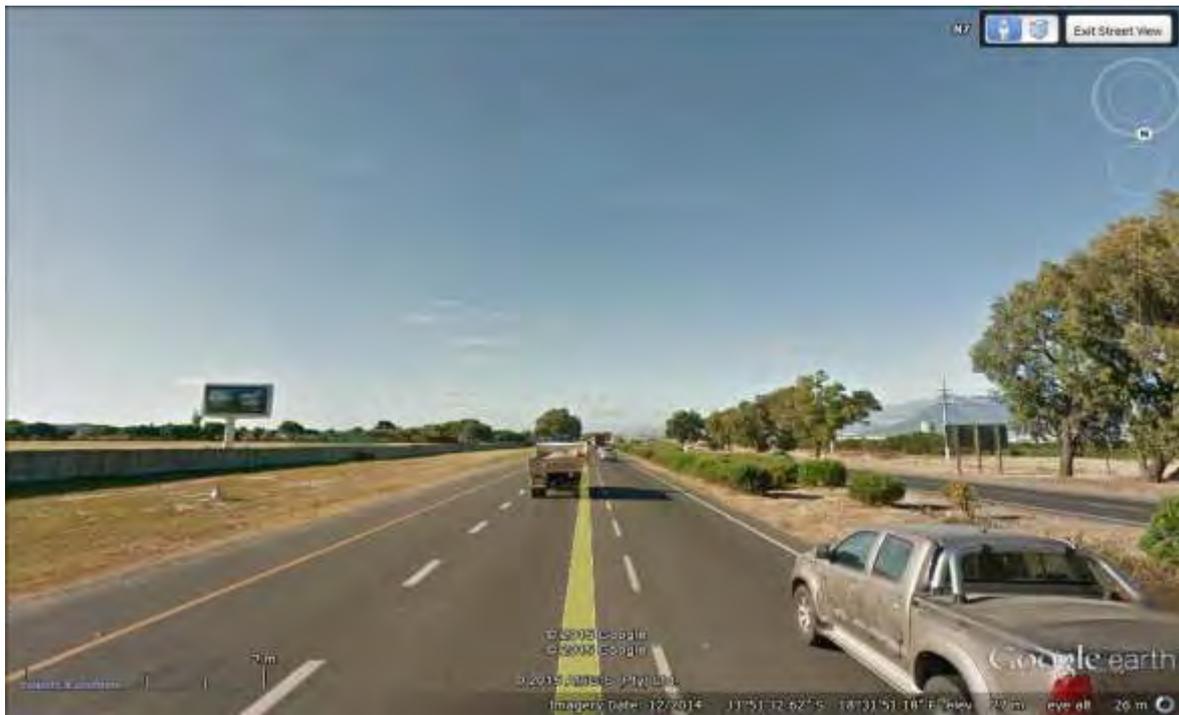
Conclusions	Arguments in this case involved the presence of pedestrians and persons sleeping in the shrubs. This clouded the issue that lies at the base of maintenance, which is that if the shrubs were trimmed to less than 1 m high, the primary function of preventing glare could still be fulfilled while illegal pedestrians could then be visible in the median.

**Figure 7- 9: Gerber: View of shrubs in median in 2014**

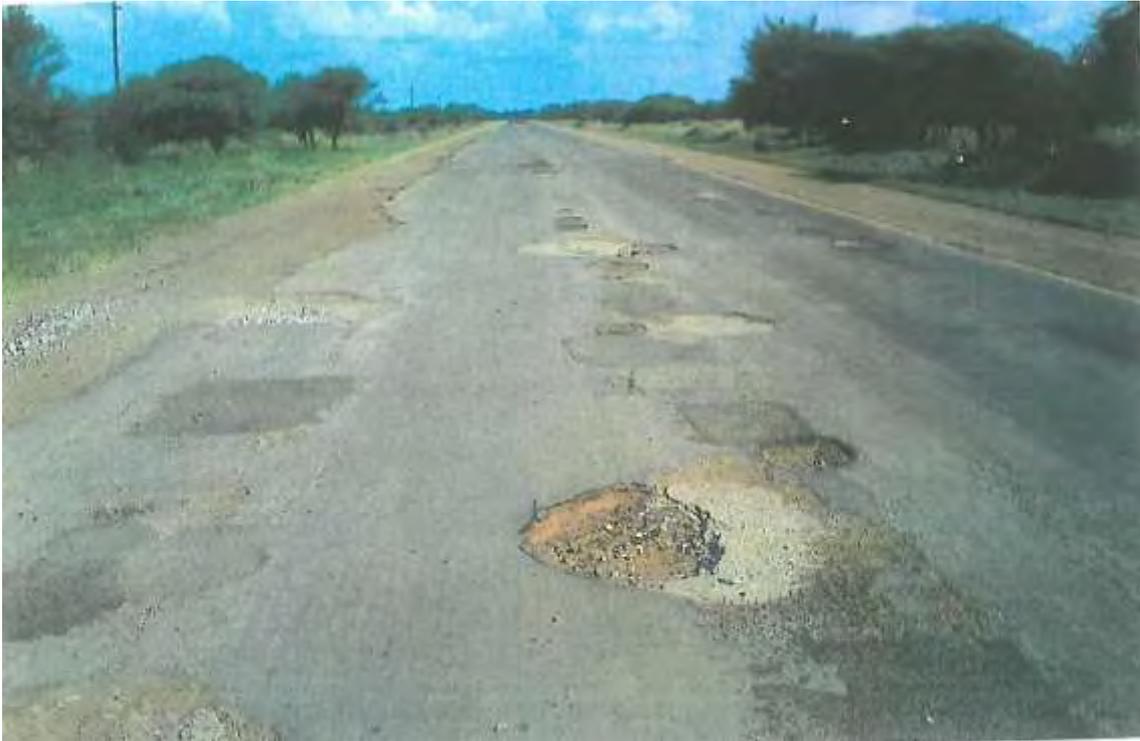
According to the experts of the plaintiff, the repair of potholes was a priority, both with regard to the safety of road users and the preservation of the structural integrity of the road. No evidence was led by the defendants to establish that by reason of the lack of funds the repair of potholes was neglected in favour of some other priority. Nor was there evidence to suggest the existence of a policy to select some potholes for repairs ahead of others and if so, the basis upon which such a selection was made. The inference of negligence on the part of the servants of the Department responsible for the inspection and repairs of potholes on this road is irresistible.

**Figure 7- 19: Matshoge: Potholes at time of accident**

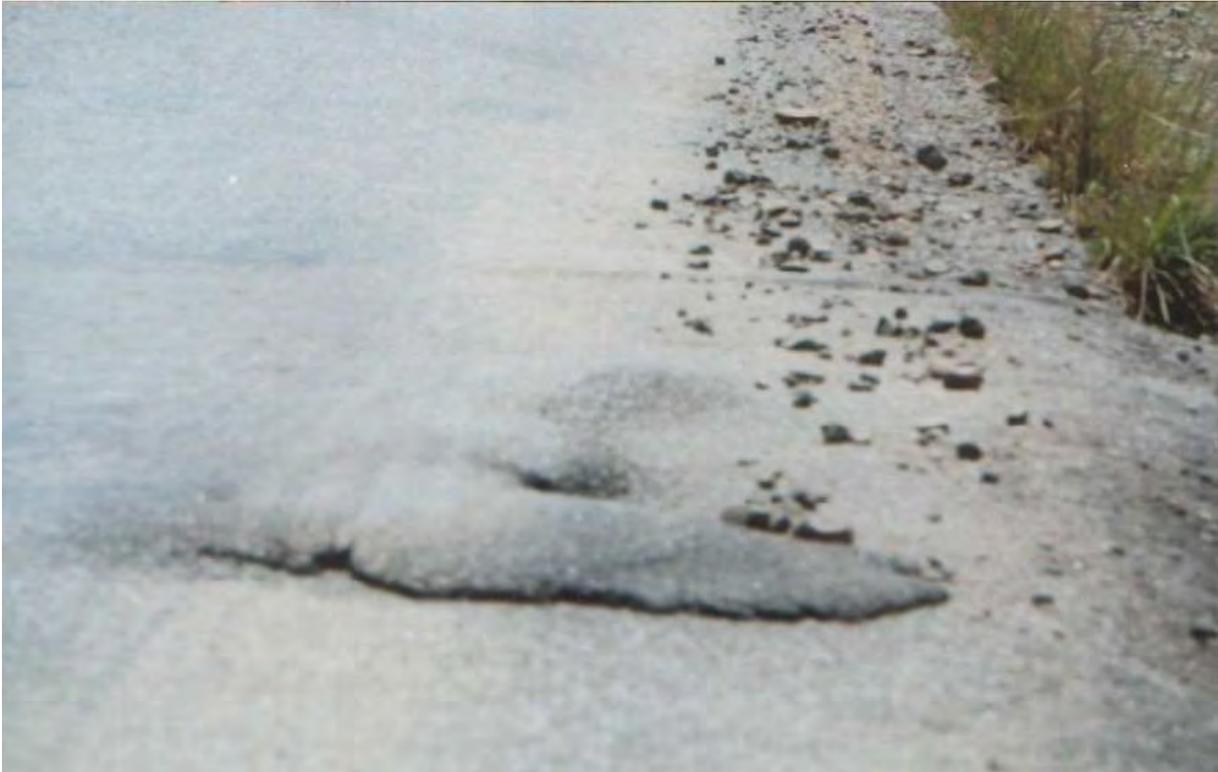
Outcome, citation if available	The province was found to be 60% negligent. Devonport v Premier Free State Province A216 2008 26 November 2009
Finding 1 Road environment	The protrusion (shoving) exceeded 30 mm height and was dangerous. The danger was foreseeable and could be repaired with little cost or inconvenience.
Finding 2 Signage	Signs should have been erected to warn of the road condition.
Conclusions	The extent of shoving exceeded 30 mm and the shape was rounded. This posed a danger to the cyclists as legitimate road user and was not visible due to the colour and shape blending in with the road. On the defendant's argument that the danger was obvious, van der Merwe J remarked: <i>"The logical conclusion of this argument is that the bigger the danger in a road, the more it would or should be apparent and therefore the less need to repair or warn against it. Once a hazard is recognised by a public authority such as the province in these circumstances, it cannot in my judgment be heard to say that injury was not reasonably foreseeable simply because the danger should be apparent to road users."</i>

**Figure 7- 21: Devonport: Shoving that caused accident**

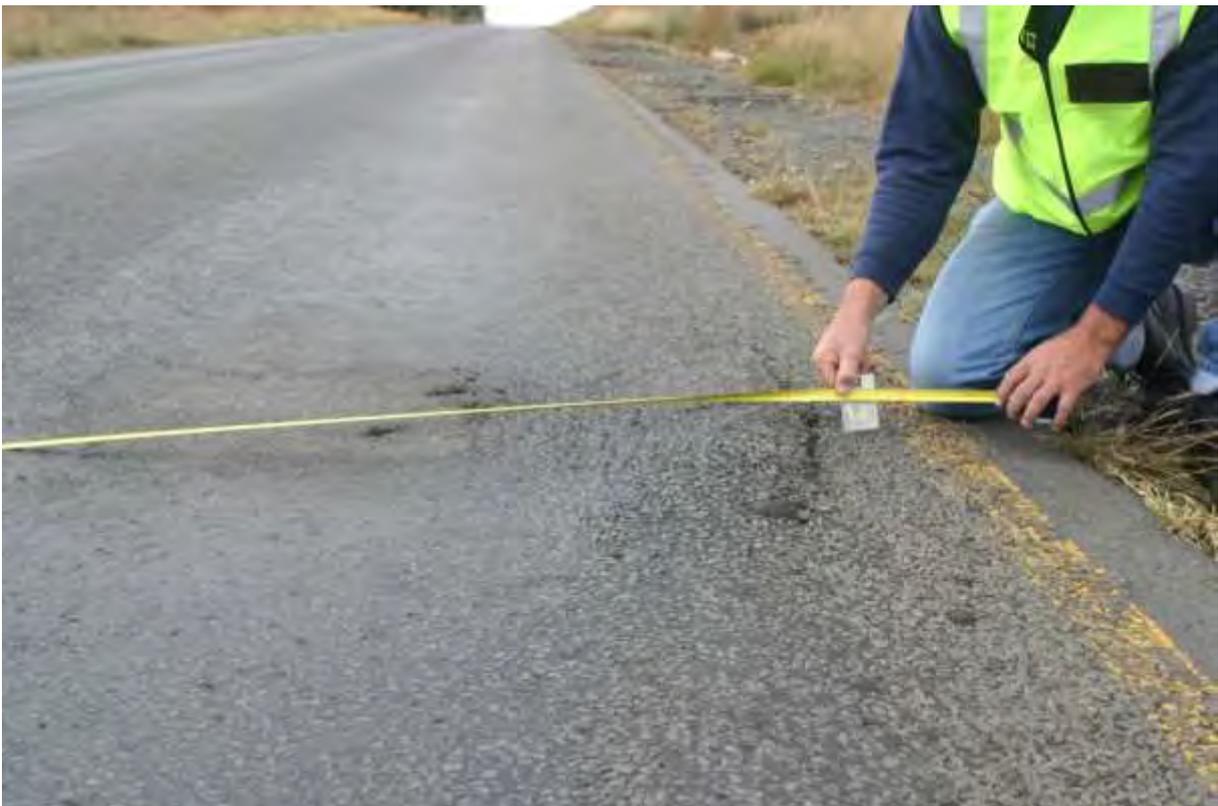
**Figure 7- 22: Devonport: Surface failure at location of accident observed on site visit**

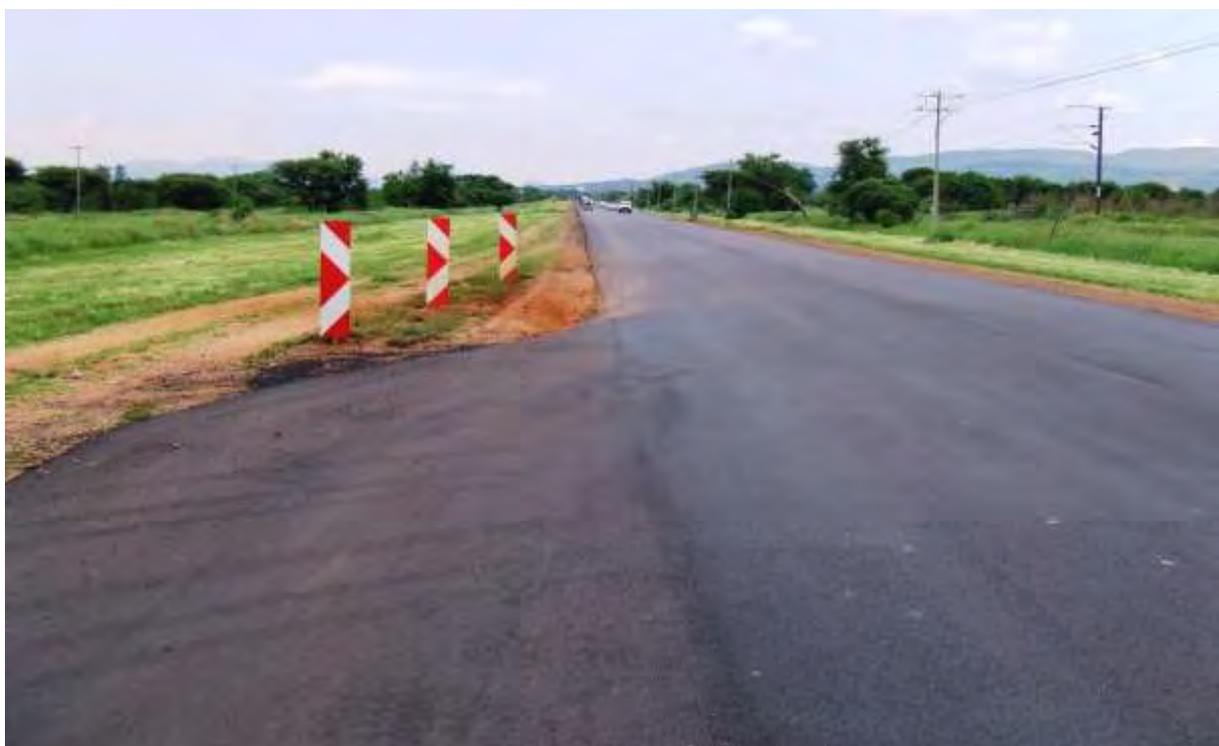
indicated. The pothole in the corner of the roadways was evidence of many vehicles clipping the gravel shoulder as they moved back to the through-lane too late. The RRM contractor did not fix the pothole, which was substantial and caused loss of control.
Finding 2 Maintenance procedures, reaction times	The RRM contractor should have fixed the pothole.
Finding 3 Signage	When maintenance work is being executed, the traffic control by means of signs and markings should be at a higher level as normal due to unexpected situations. The painted island taper should have been replicated by means of delineators.
Conclusions	Maintenance procedures such as resealing can result in dangerous conditions. The road authority should ensure a higher level of traffic control during the construction period as conditions change continuously.

**Figure 7- 23: Herbst: Lane drop with no marking after resealing**

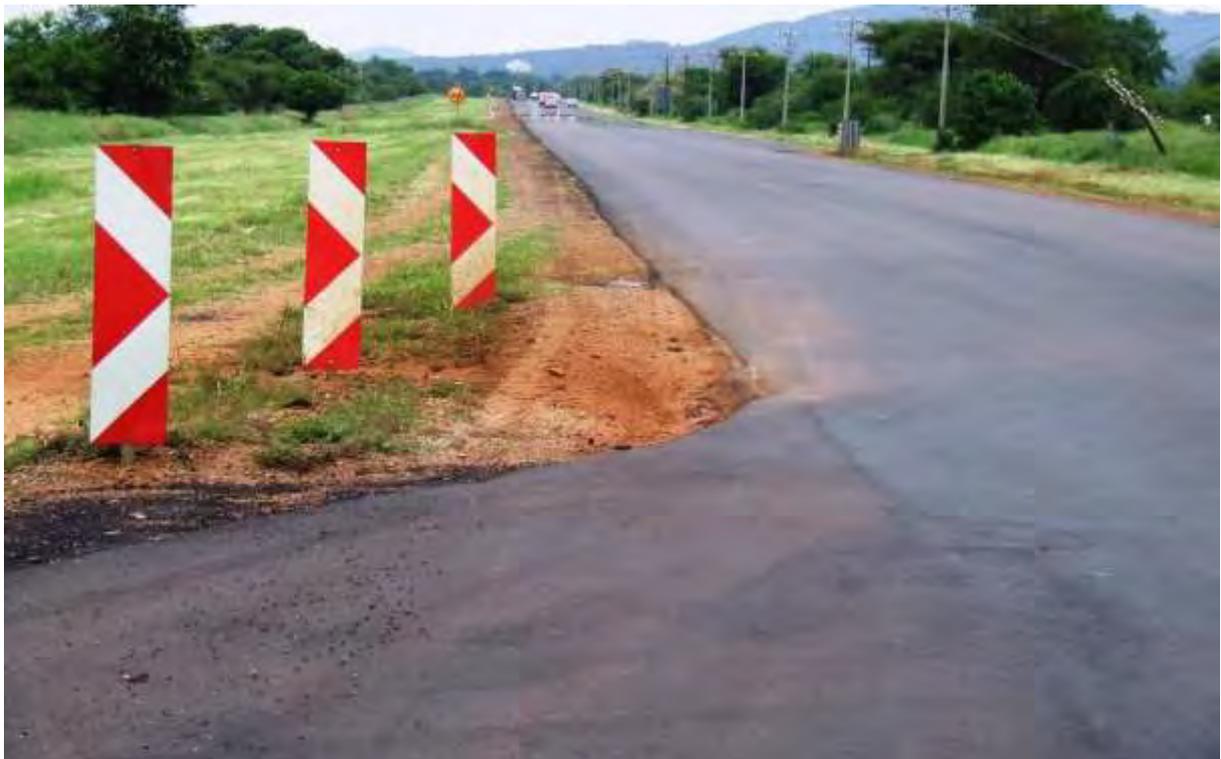
**Figure 7- 25: Herbst: Pothole at end of lane**

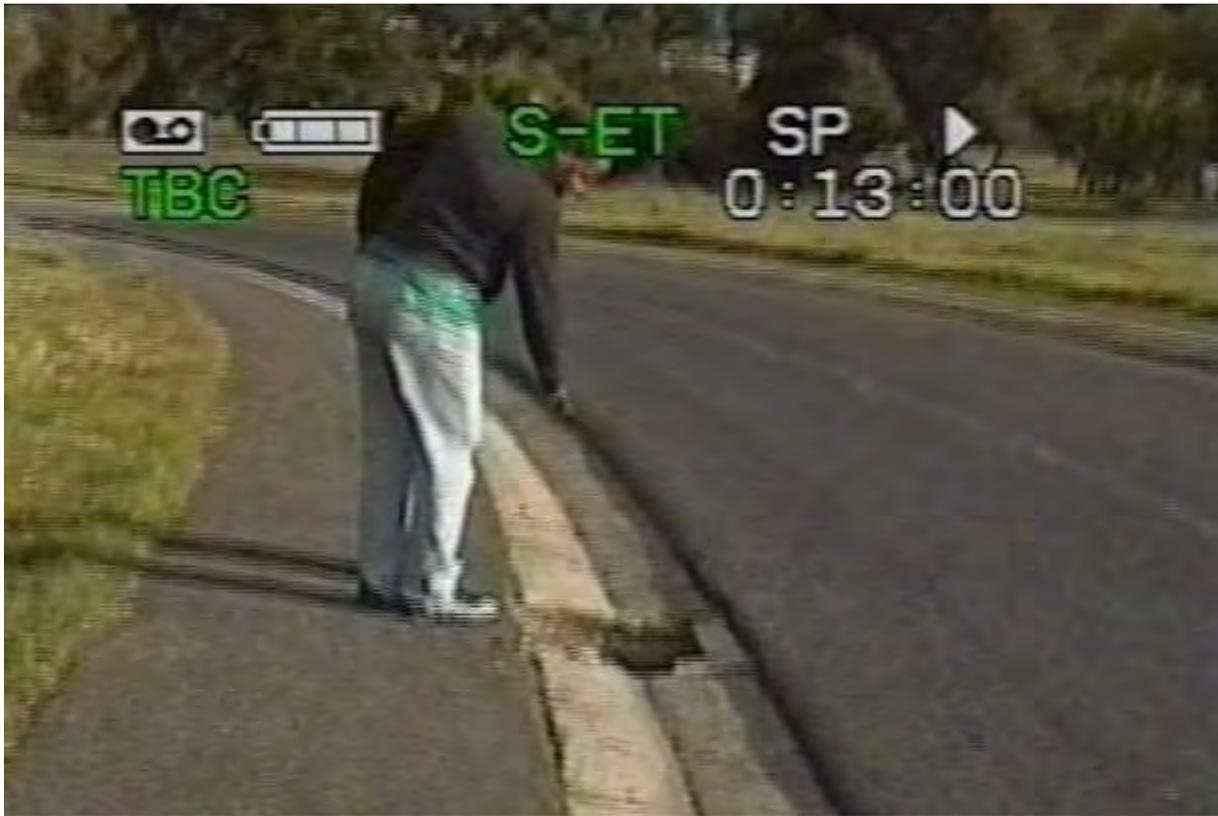
Maintenance procedures, reaction times	course of the expert investigation in 2010, a broken grid was observed on one of the other ramps. It was not repaired until it was reported and then it was replaced the same day
Conclusions	The specifications for inspections and reaction times were adequate and a RRM contractor was duly appointed. The execution of the inspections was, however, lacking.

Figure 7- 28: Mothlapudi: Open drain as recorded the day after the accident

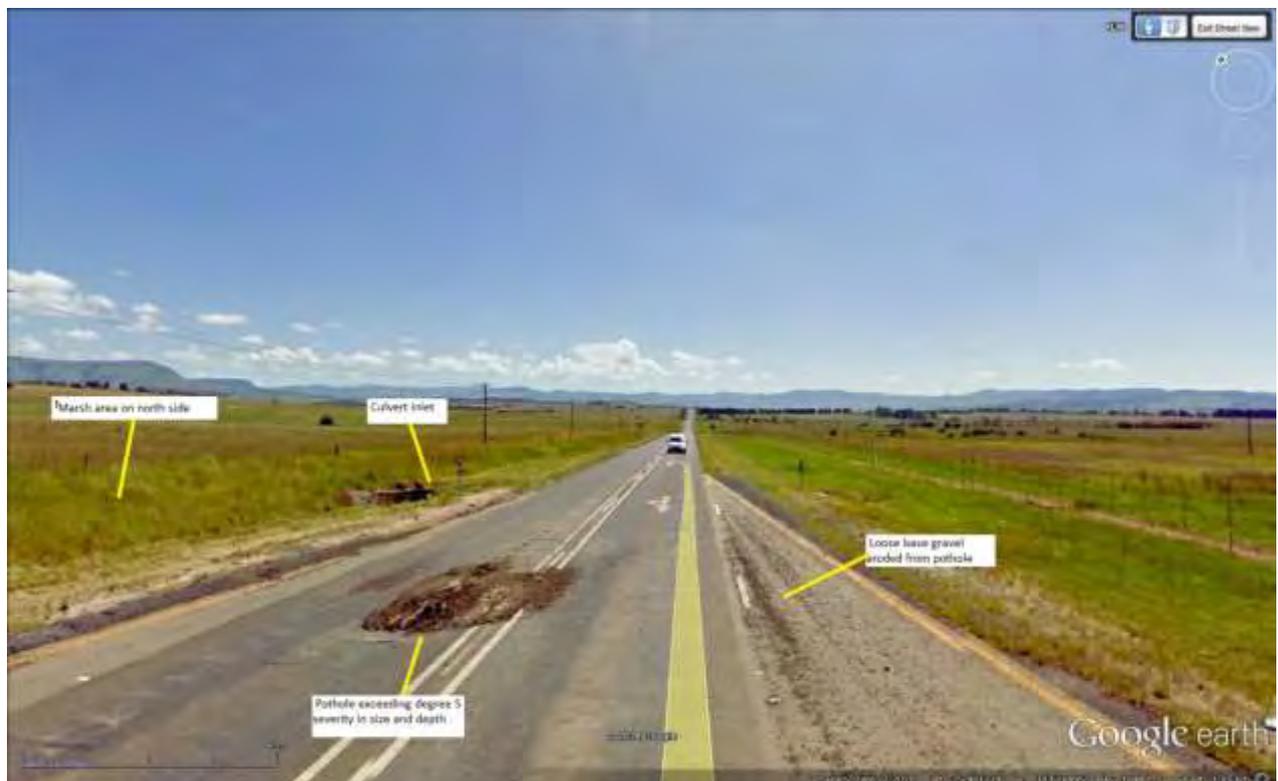
**Figure 7- 29: Madonsela: Pothole on R38**

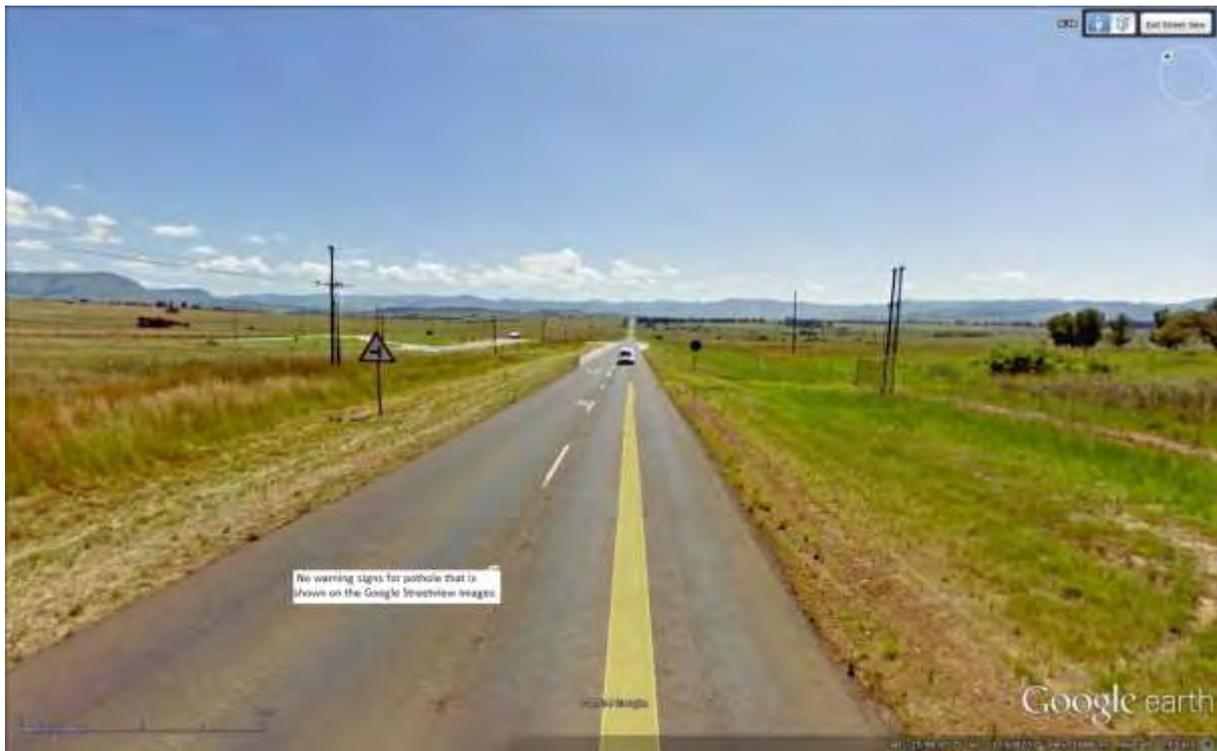
Finding 3 Signage	The contractor presented photographs of temporary signage on the approach to the pothole that would be adequate. Although not tested in evidence, it appeared that the signs were in place for the repairs the previous week or occasions and were taken down after the repairs.
Conclusions	The road authority and its independent contractors settled the claim in acknowledgement of their legal duty and negligence.  The dimensions of the pothole exceeded Degree 5 by far.  The superficial maintenance was done within contractual reaction time. The deep base failure to address fundamental causes was not done in a reasonable time and lead to recurring failures.  Adequate signage was not provided and maintained. Signage needed to be site specific, as a general warning of potholes at the start of the road section would not have had credibility due to the small potholes already repaired.

**Figure 7- 30: Madonsela: Lack of signage on approach to pothole on R38**

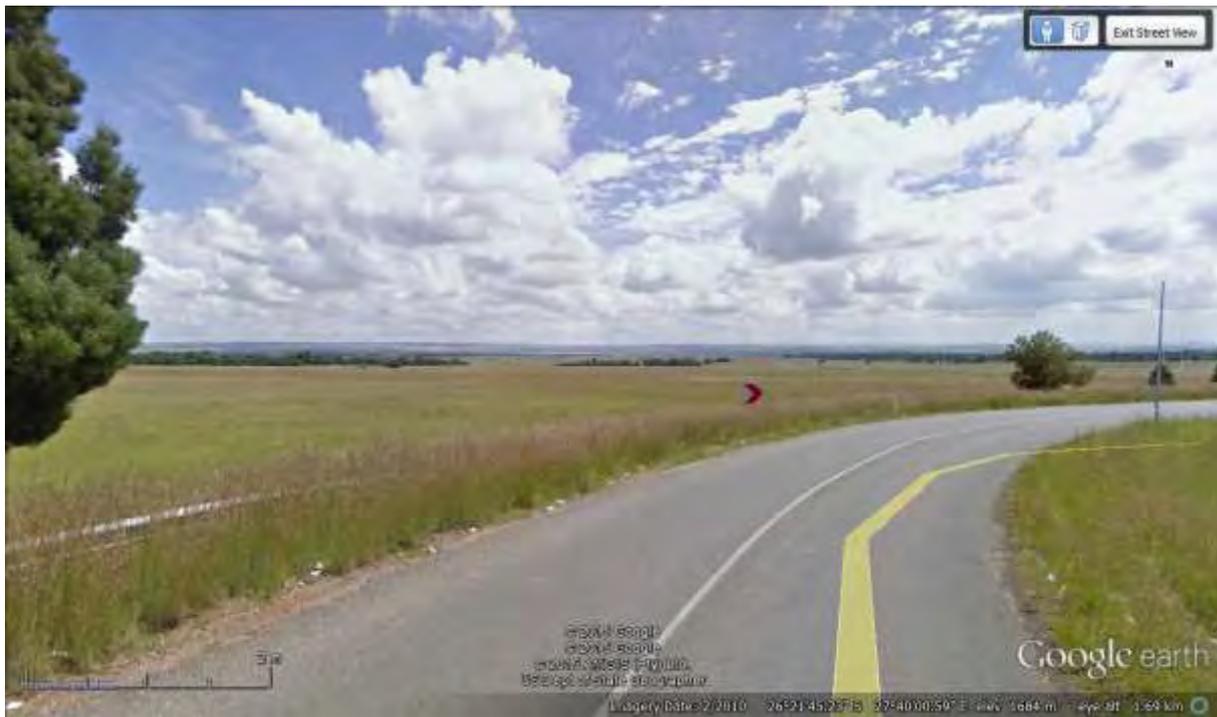
**Figure 7- 34: Zentgraff: Guardrail too low and partially down**

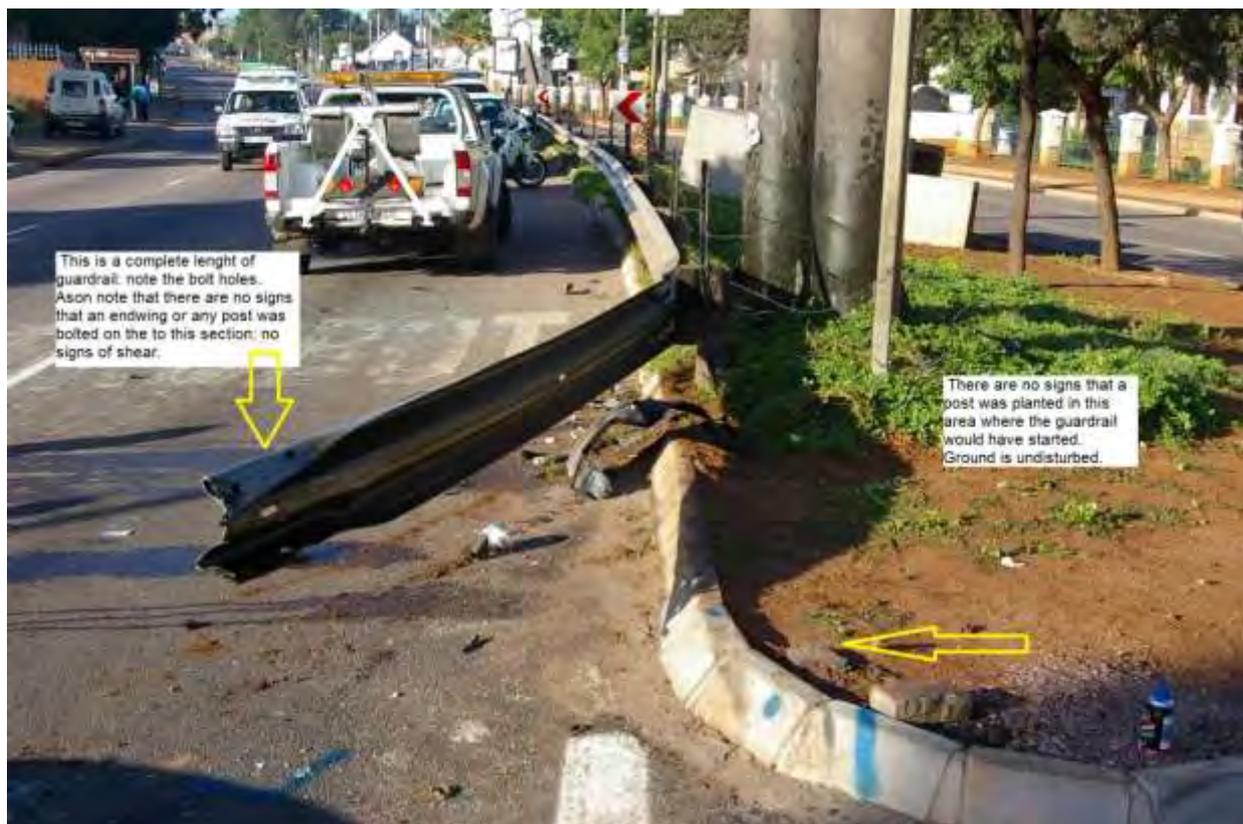
Figure 7- 35: Boshoff: Suspended guardrail end

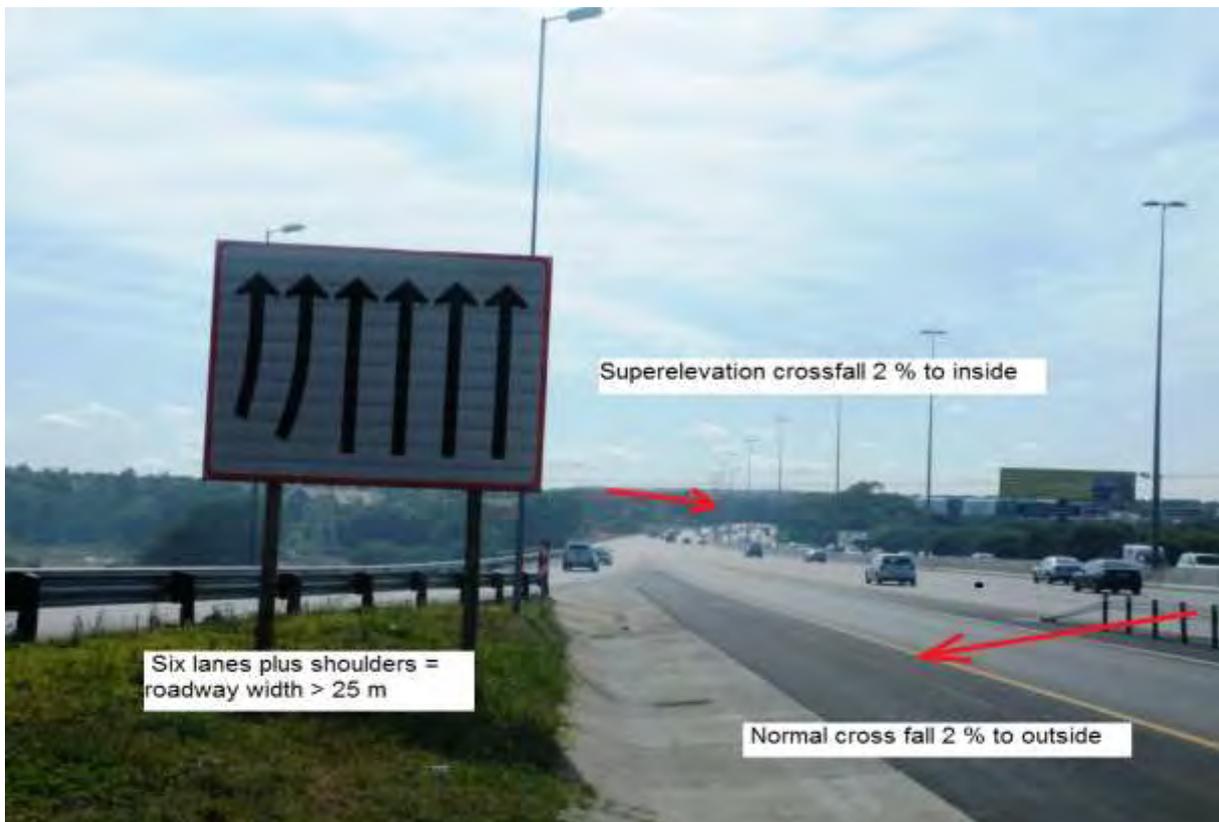
Figure 7- 42: December: Cross fall of road before and in curve

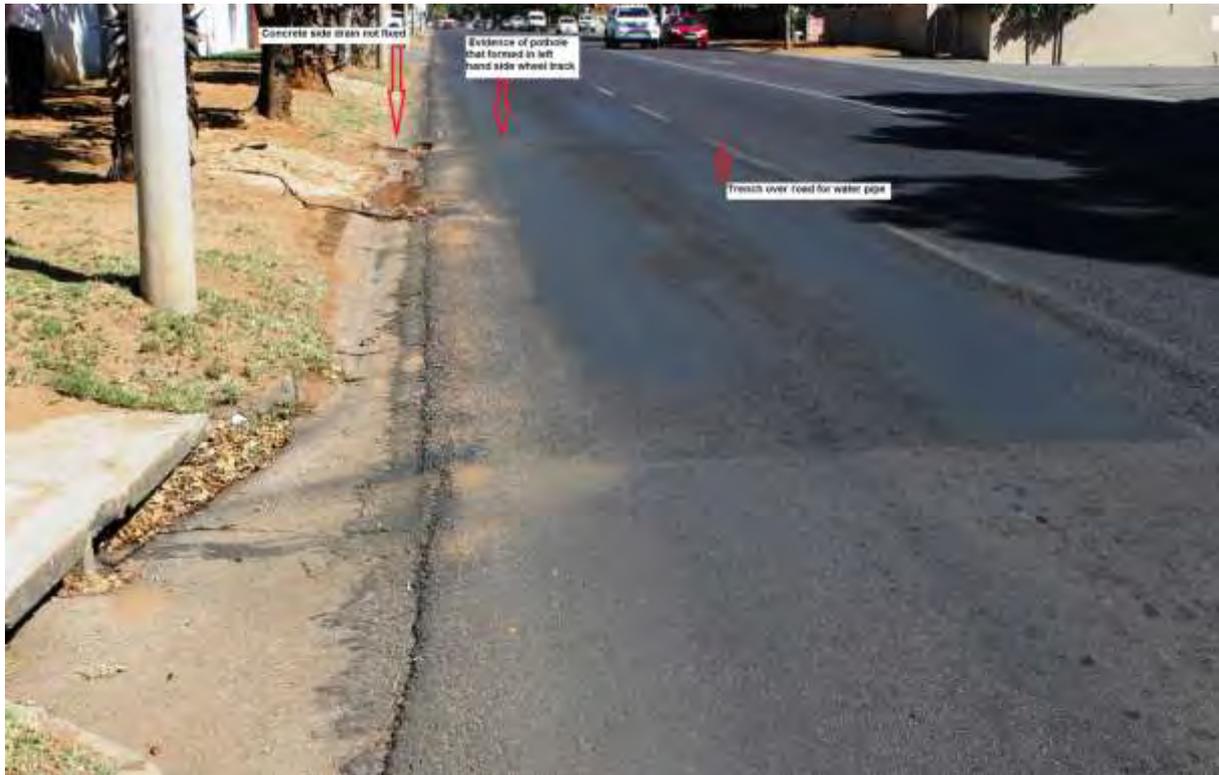
**Figure 7- 45: Pienaar: Pothole in wheel track after trench not reinstated**

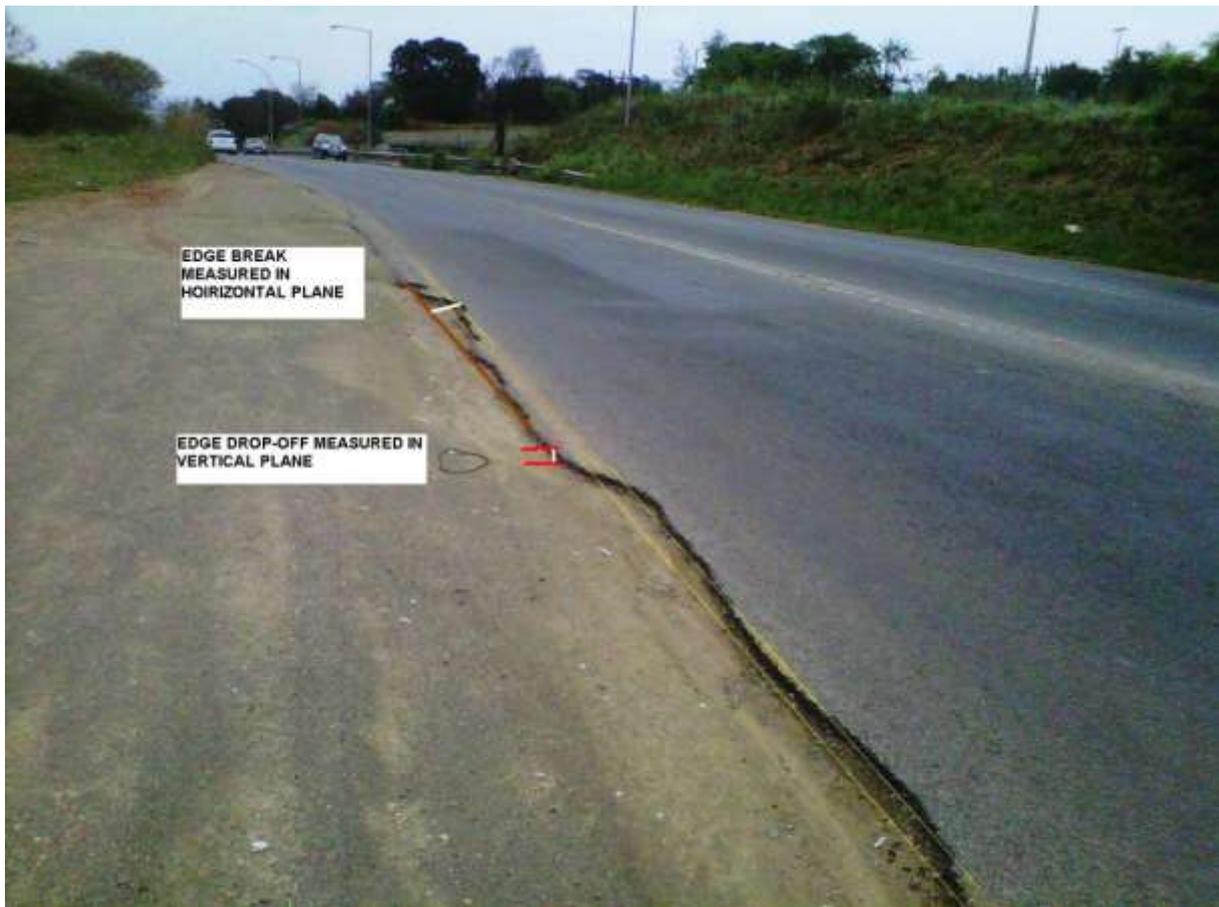
**Figure 7- 47: Deysel: Edge break and drop-off**

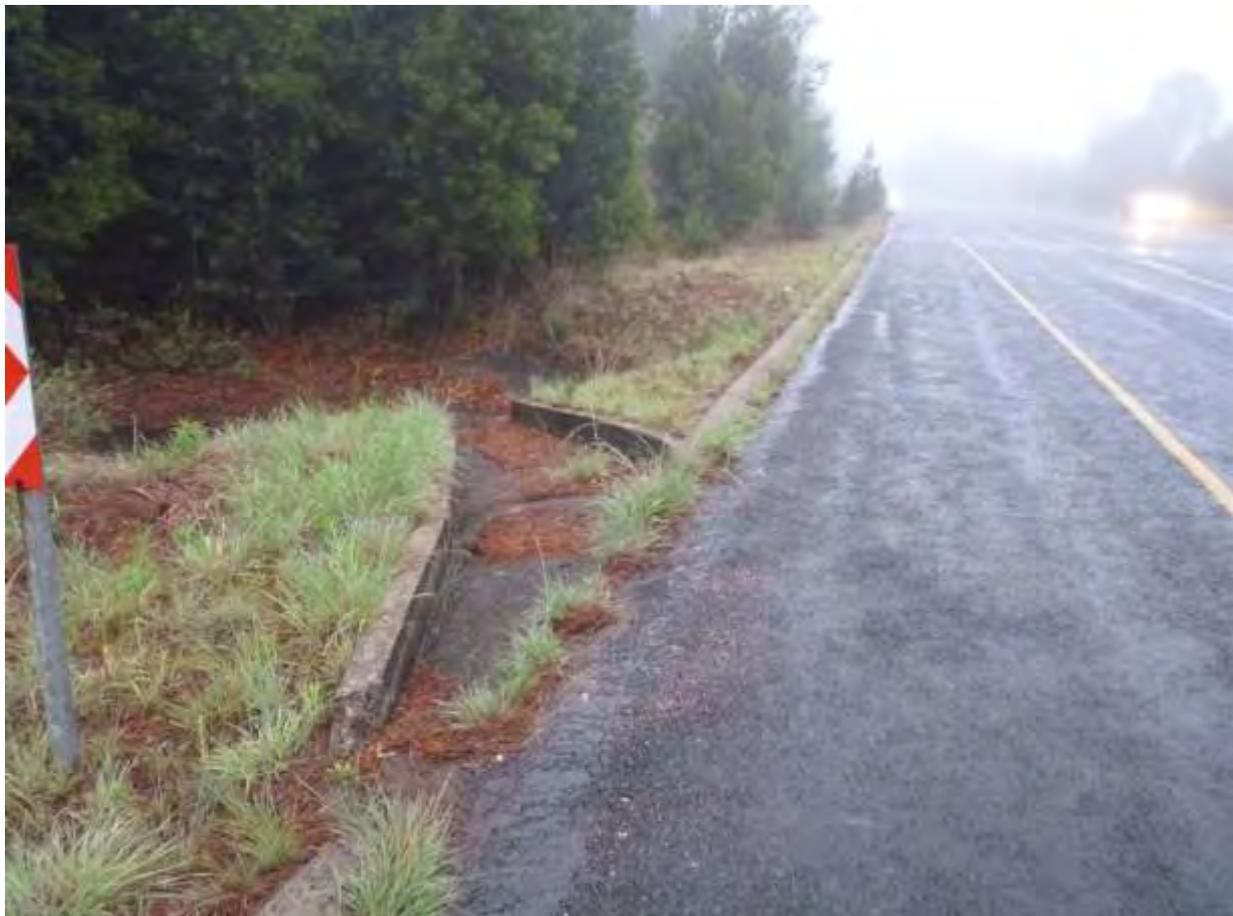
**Figure 7- 50: de Beer: Blocked down chutes**

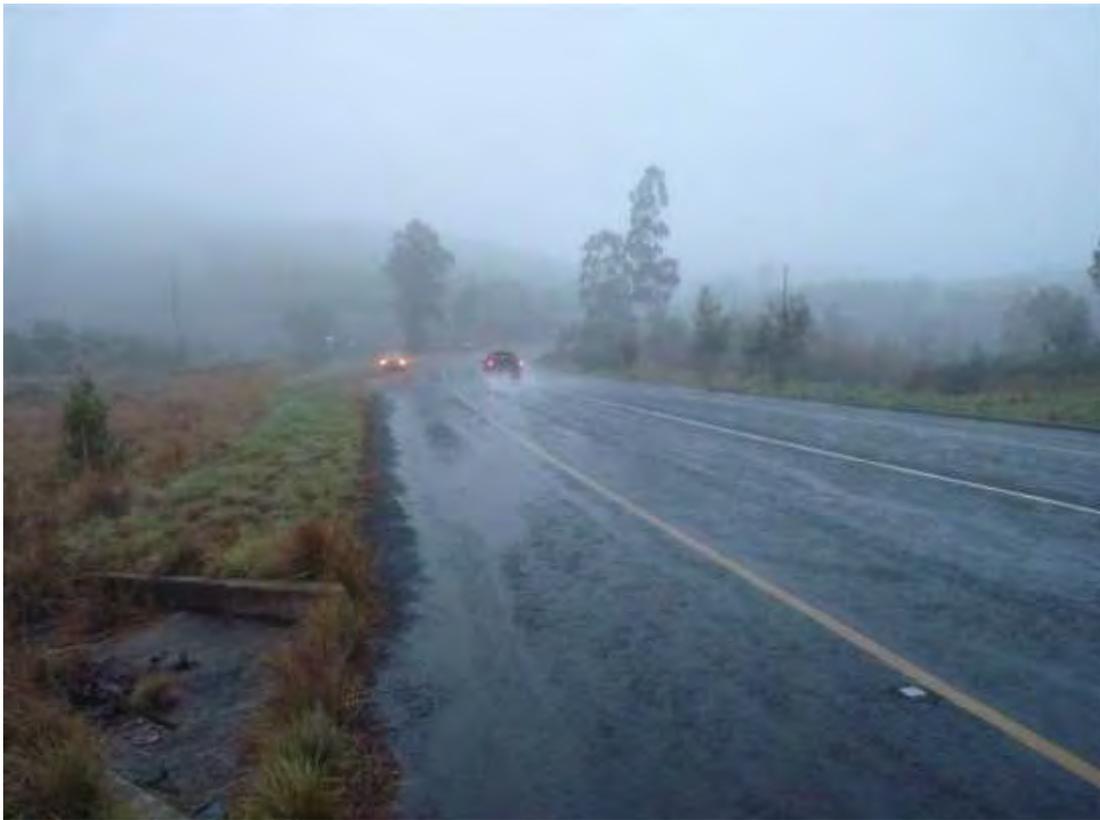
Figure 7- 51: de Beer: Drainage over road at superelevation development

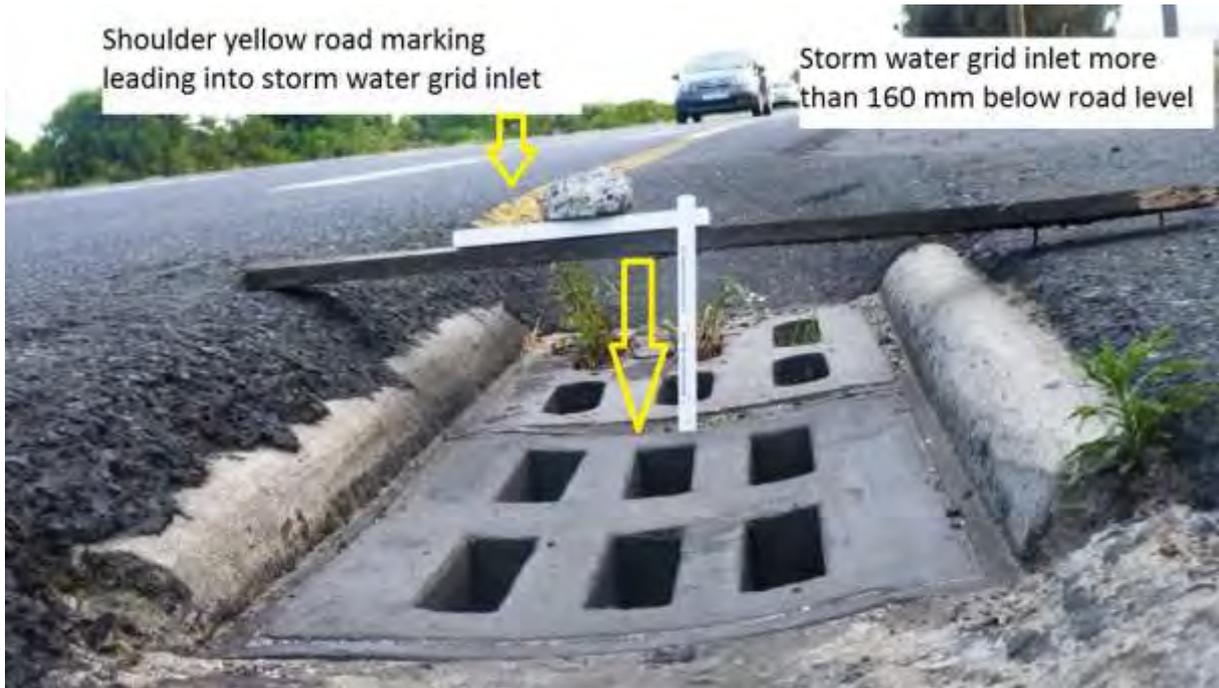
Figure 7- 55: Buijs: Drop-off due to asphalt build up at inlet grid

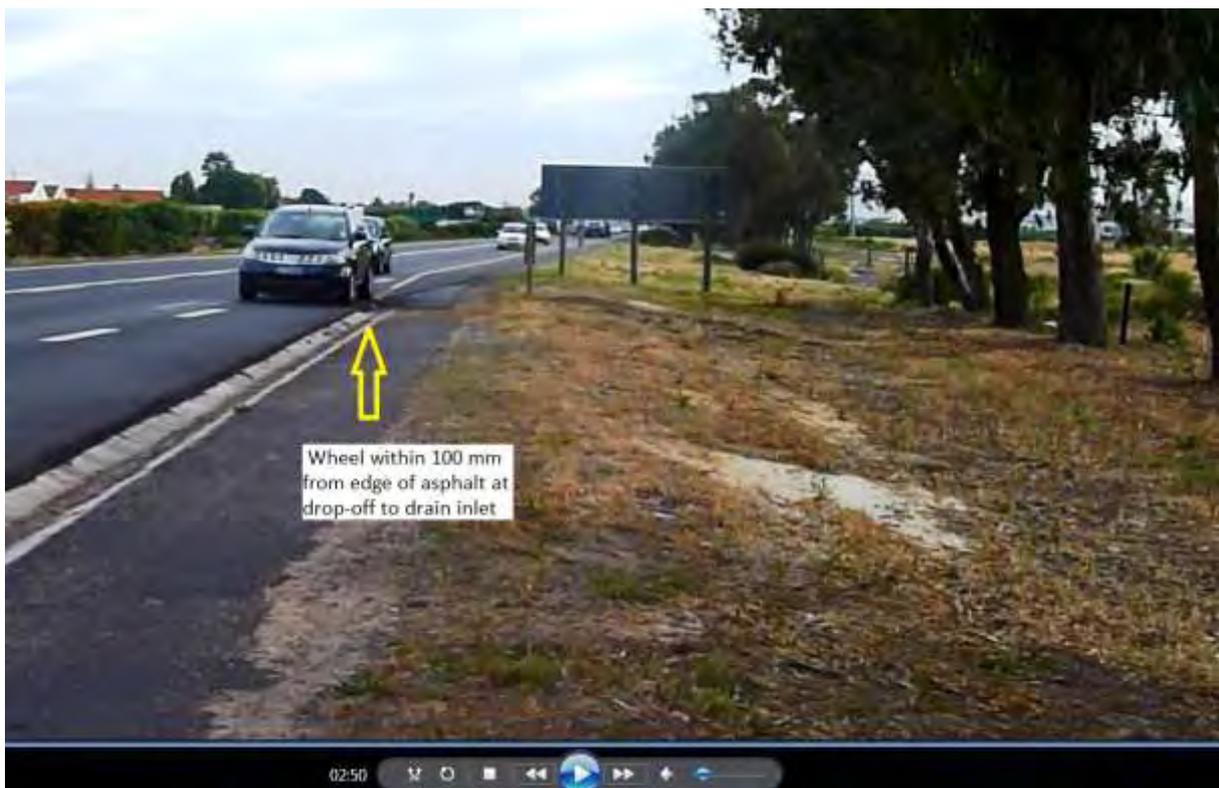
Figure 7- 56: Buijs: Hazardous drop-off on driving line

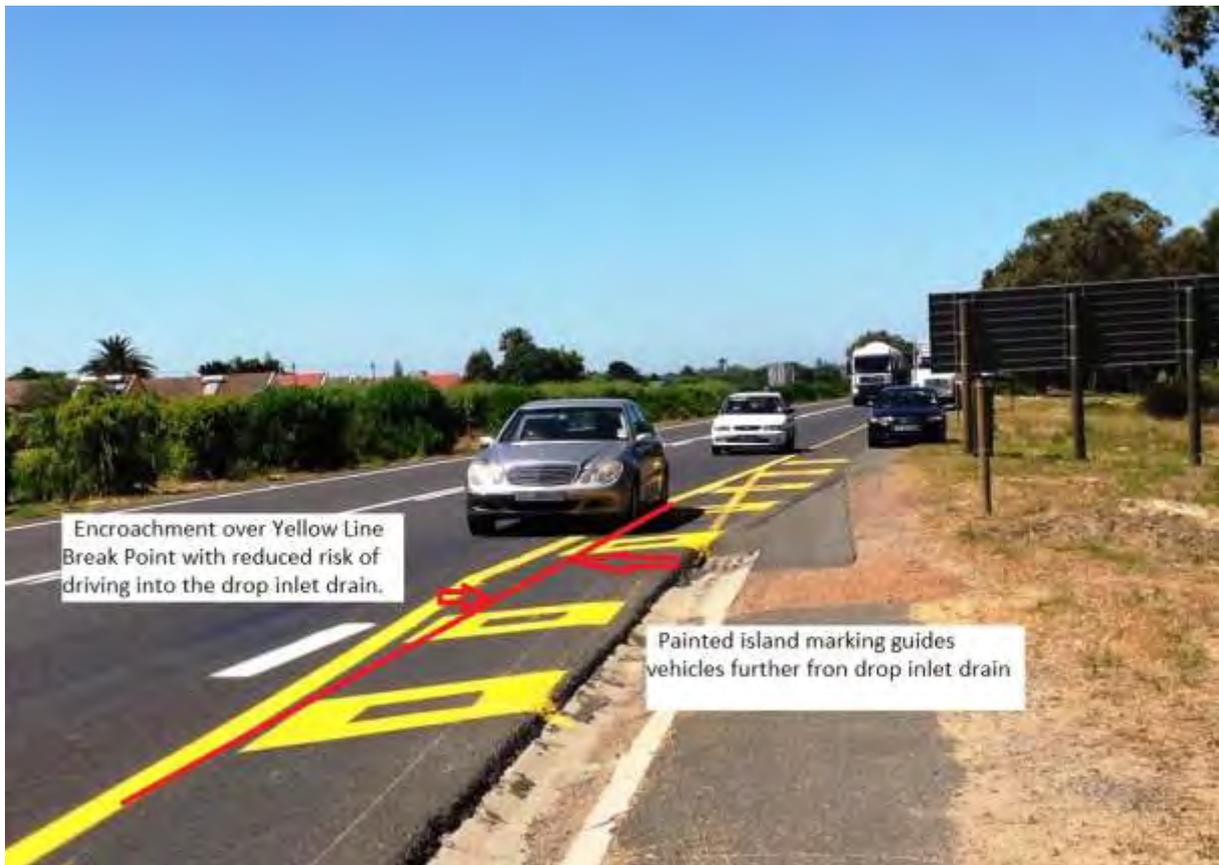
**Figure 7- 57: Buijs: shift from hazardous drop-off with painted island**
