REDUCING PERCENTAGE OVERSIZE AGGREGATE IN GRAVEL WEARING COURSE MATERIALS BY LINEAR CRUSHING

Adjunct Prof. Herman Wolff^{1,2}, Mr. Stephan Schoeman², Mr. Xander Smuts², Mr. Johan Hendriksz²

¹University of Stellenbosch Department of Civil Engineering, ²Western Cape Government Department of Transport and Public Works
stephanus.schoeman@westerncape.gov.za

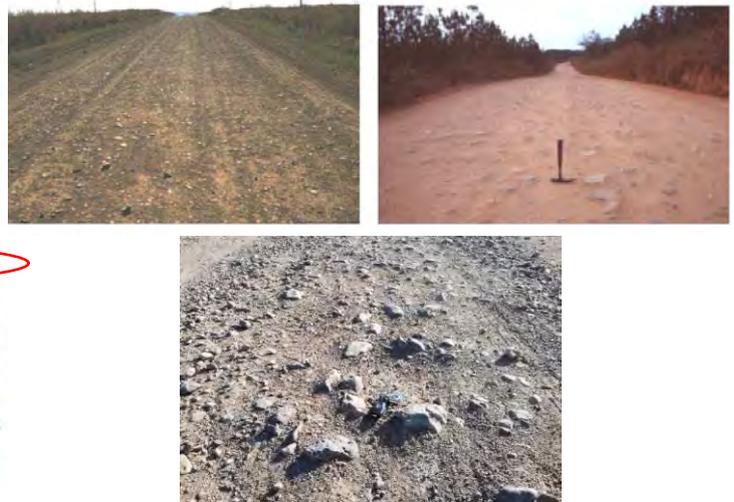
The Department's unpaved road network comprises of approximately 25 000 km, of which around 10 000 km are actively managed and maintained. It can be seen from **Figure 1** that up to 65 percent of the unpaved road network is in severe and warning stages with respect to stoniness fixed. The second most critical defect is potholes with ten percent of the unpaved road network in the severe and warning stages. Examples of unpaved roads with stoniness fixed defects are shown in **Figure 2**.

Figure 2: Unpaved roads with stoniness fixed defects [3]

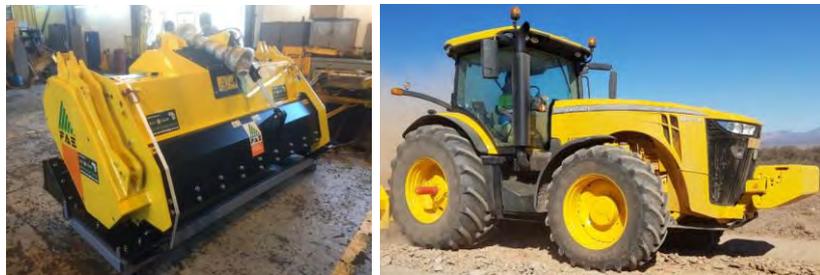
Various types of linear crushers were investigated, evaluated and tested. It was found that the linear crushers used for agricultural applications were generally not suitable for the Department's application and that larger and stronger crushers are required. However, linear crushers that are pushed into the ground hydraulically were considered an over application for the Department's needs. The Directorate Mechanical Services of the Department did a detailed study on 24 types of crusher and tractor combinations that could be suitable for the application the Department envisaged. The parameters evaluated as well as the allocations assigned to each parameter for the crusher and tractor combination selected are shown in **Figure 3**. A FAE STC200 linear crusher and a John Deere 8245R tractor as shown in **Figure 4** were acquired after the detailed analyses of available types and models.

Figure 4: FAE STC 200 linear crusher (left) and John Deere 8245R tractor (right).

- i. The Directorate Mechanical Services of the Department did a detailed study on 24 types of crusher and tractor combinations that could be suitable for the application the Department envisaged. A FAE STC200 linear crusher and a John Deere 8245R tractor were acquired after the detailed analyses of available types and models.

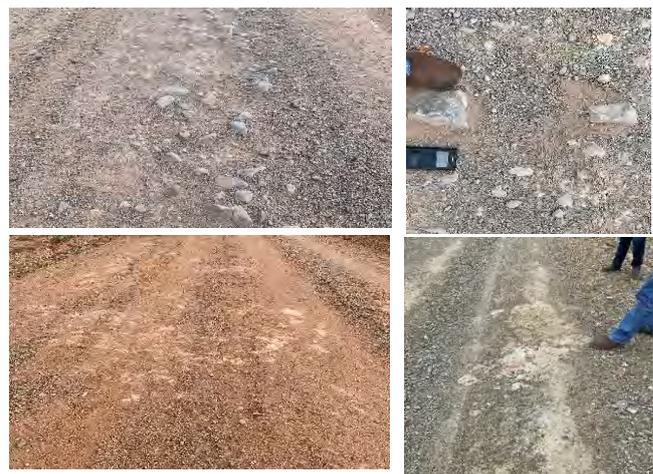
Four trial section sites were selected near Oudtshoorn to test the selected tractor and crusher combination. The trial sections were set at 250m long and between 6m to 7.5m wide. The materials present at the four selected sites consisted of quartzite, greywacke, dorbank and shale wearing course as these are the materials generally used in the area as wearing course. The typical appearances of the wearing course materials present on the test sections are shown in **Figure 5**. The Dorbank trial section was not completed as the material was too hard to rip with the modified rippers of the CAT D7H dozer. The trials were conducted in the period June to July 2019.

Figure 5: Material types on the four trial sections. Quartzite (top left), Greywacke (top right), Dorbank (bottom left), Shale (bottom right)

- ii. The linear crusher was utilised on four trial sections consisting of material of various hardness, namely quartzite, greywacke, dorbank and shale. The trials were conducted in the period June to July 2019.

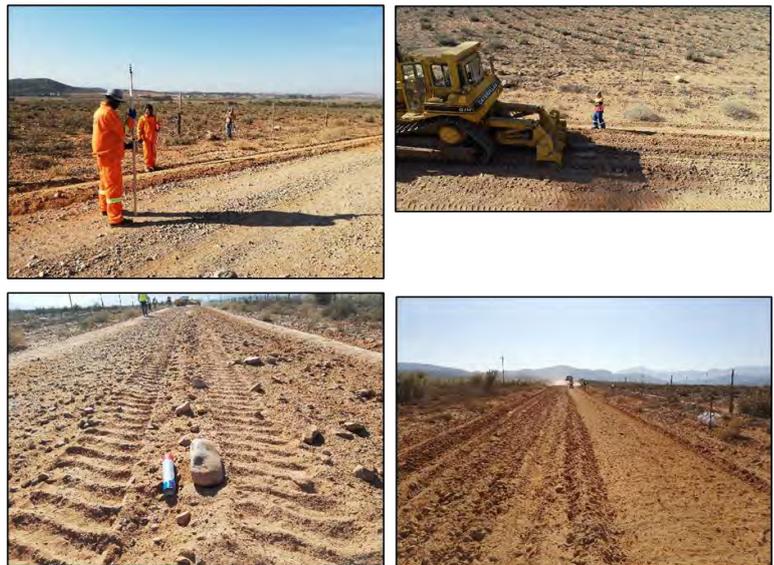
Figure 7: Trial section construction sequence: Setting out (top left); Ripping the in-situ material (top right); Blading oversized material onto the roadbed (bottom left); Crushing of in-situ material (bottom right).
